Aesthetic Rehabilitation of Maxillary Central Incisors: Zirconia Crown and Porcelain Veneers

The objective of this case report is to highlight the steps of dental rehabilitation using ceramic veneers reinforced by lithium disilicate and zirconia crown.

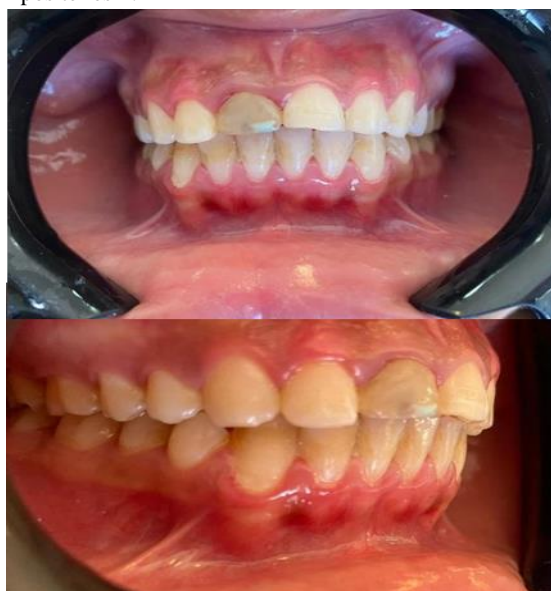
Intraoral examination showed a fracture of more than 3mm on the upper left central incisor (21) reconstructed with composite resin.

Figure: Intra oral view Initial smile

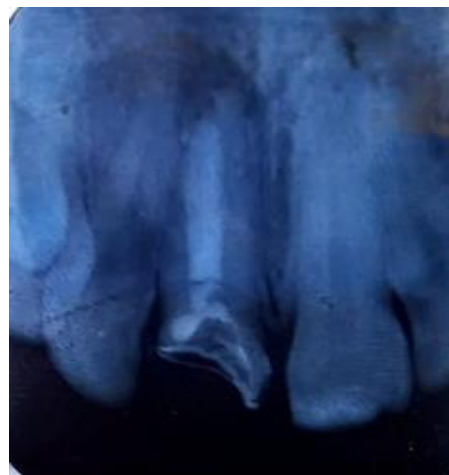
11: An immature tooth with open apex and thin dentinal walls due to an old trauma, the endodontic treatment was completed with the absence of any periapical lesion or any additional fractures involving the root (figure 2).

21: enamel fracture with limited loss of substance

Figure: The initial periapical X-ray shows maxillary central incisors, radiographic confirmation of MTA placement, note the thin dentinal walls and large root canal space

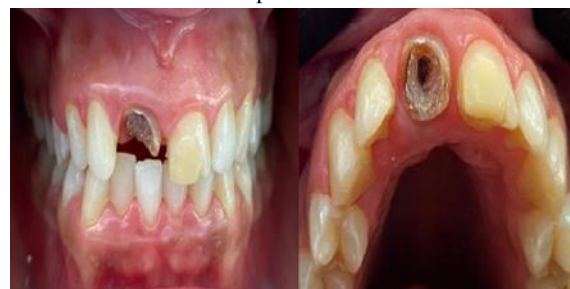
Figs A and B: intra-oral view after debonding the provisional crown

- After debonding the provisional crown, we evaluated the remaining walls and a **fiber post** reconstruction was indicated. Due to big width of the root canal, we indicated the technique of customized fiber post with the use of Ribbond.

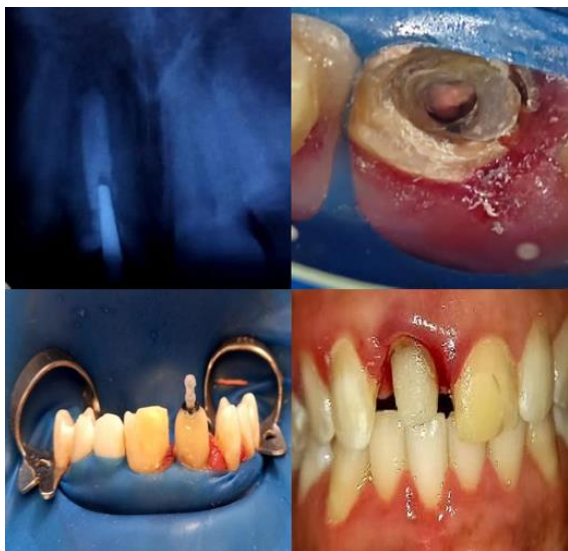
Figs A, B, C and D:
 A: checking the fit and adaptation of the customized fiber post;
 B: Tooth isolation by rubber dam;
 C: Fiber post cementation and core build-up; D: tooth preparation

After root canal preparation, a periapical radiograph was employed to check the preparation quality and to select the fiber post size

In the mentioned case, it was apparent that the root canal had been enlarged, and the biologic width was compromised due to the initial treatment when the incisor was younger (6). To appropriately address this, a fiber post, reinforced with Ribbond, was employed to properly fill the enlarged canal. Both the fiber post and Ribbond were utilized in conjunction with a dual-cure composite resin during the post's placement in the root canal, ensuring effective root reinforcement for the tooth. (8)

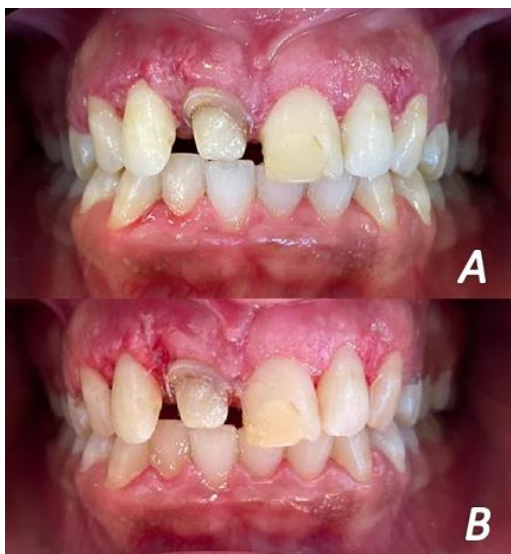
Figs A and B: (A) after crown lengthening and (B) suture removal (10 days), the harmony of mucogingival tissue is re-established

- For the passive eruption, a **crown lengthening** procedure was done from canine to canine which increased the cervico-incisal length of the teeth by 2 mm to fix the passive eruption (Figure).

A potential resolution to address the aesthetic, periodontal, and restorative challenges is the crown lengthening procedure. This surgical intervention is designed to eliminate periodontal tissue with the goal of increasing the clinical length of the dental crown. (11). Alveolar bone reduction became necessary due to the distance between the cemento-enamel junction and

the bone crest being less than 3 mm. The procedure involved opening a flap to visualize the entire bone. It is advised to remove sutures two weeks post-surgery to promote the maturity of wound healing. (12)

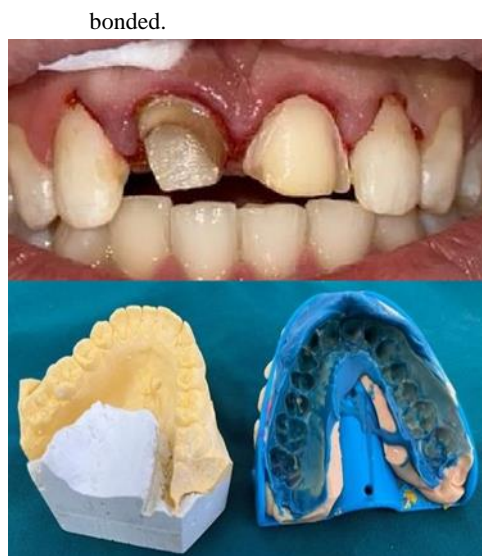
Figs A and B:
 A: gingival retraction B: master impression

- After healing, a conservative tooth preparation was done to receive a porcelain veneer on the left central incisor (21).
- The master impression was made using light and heavy-body consistency polyvinylsiloxane (Virtual 380, Ivoclar Vivadent, Amherst, NY, USA ®)(Figure). And a temporary prosthesis was

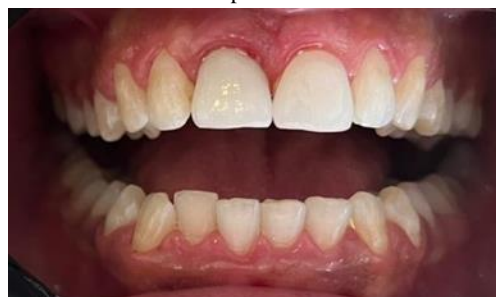
Figure: Zirconia crown and veneer try-in

- Prostheses were fabricated using indirect CAD/CAM technique. Zirconia crown and the veneer were tried. We noticed the need of modifications concerning the crown's final shade and shape.

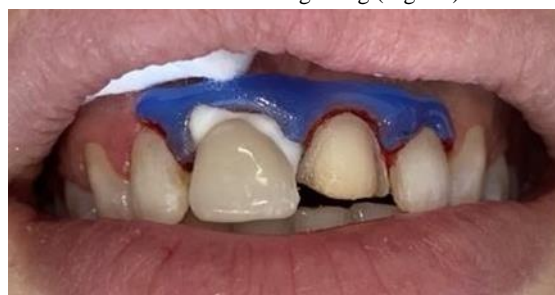
Figure: crown sealing

- Prostheses were modified, aesthetic and occlusion relationships were checked and the crown was sealed after ceramic glazing (Figure).

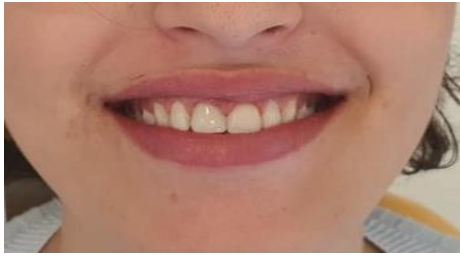
Figure: Final result

- Then, the veneer was cemented.
- Final result showing an improvement of the smile:
